## Motor and drive tests keep lift station running during upgrade

### Application Note

### Testing Functions Case Study

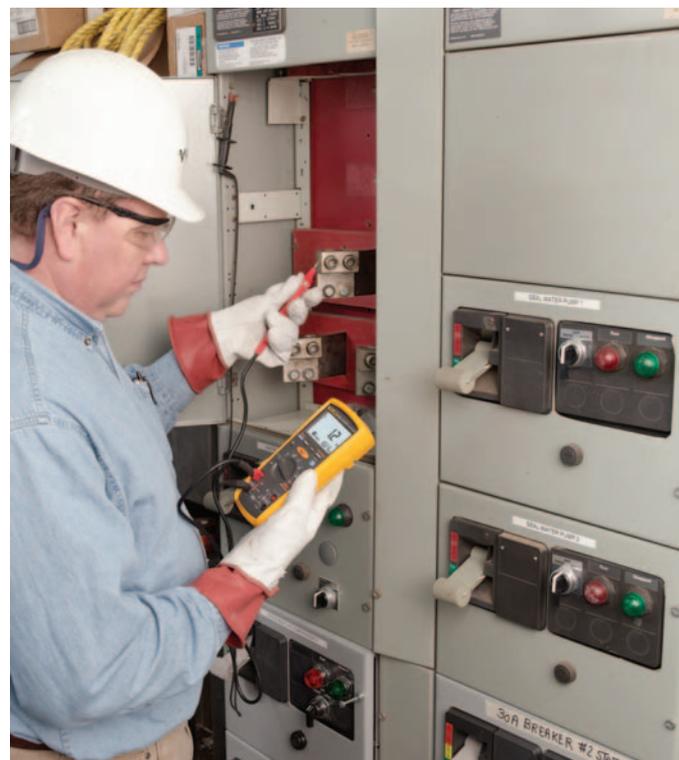
Steve Uhrich tests resistance of drive cabling.

Prior to connecting the new system to utility power, Uhrich and Glazier tested the incoming cabling and switchgear. The 1000 volt insulation testing and continuity functions of the 1587 were used during this initial testing. They insulation-tested each of the conductors to ground and to each other. During this phase of testing they found that one of the phase conductors from the fused disconnect, feeding the temporary switchgear, had only 400 k ohms resistance to ground. It should have been at least in the megohms. They replaced the cable before proceeding.
